Paper presented in the 13th IASC International Conference
Hyderabad, INDIA, 10th-14th January 2011

**Title: The Challenges of Managing Increasing Landslides
Vulnerability in Mount Elgon ecosystem, Uganda: A Case of
Human Interactions with its Environment on the verge of
collapsing.**

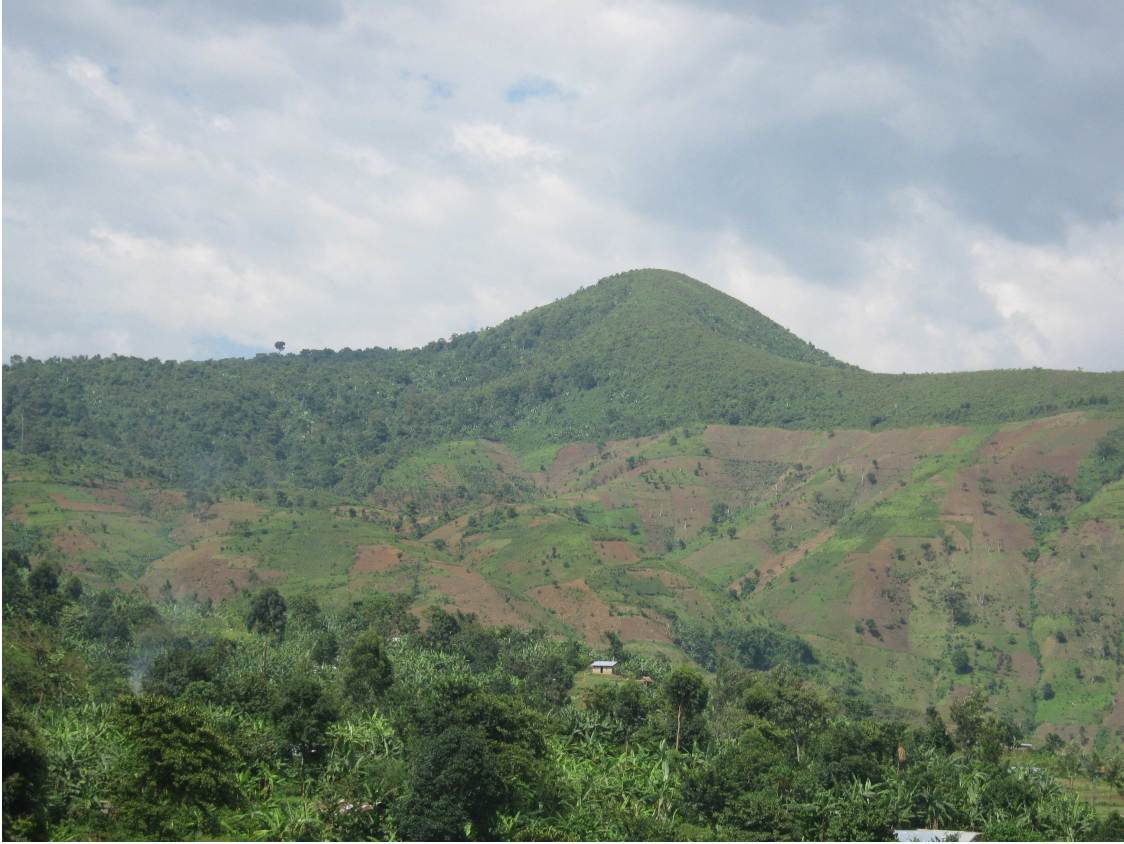
B-Encroachment area of the village sometimes up to 5kms inside the park

1-Few Eucalyptus trees for domestic use 2-contour with planted grass growth for animal feeding 3- excavated footpath with serious erosion infiltration effects 4- excavated slope to create flat area for house construction leading to increase infiltration and water pounding 5- Park boundary pillar in peoples field 6-usualy annual food crops planted in the park 7-hyrostatic pressure in water filled tension cracks enhances slope failures with increased infiltration 8-weak line of crack with high potential for land slide 9-unencroached forested park area.

Figure 5: Photograph of a typical MFNP boundary village with agricultural encroachment in the national park seen in the middle ground

Another factor contributing to landslide cause significantly is excavations. The survey found out that 82% of the households interviewed had excavated by digging away large areas of slope to create flat surfaces. On Mount Elgon, slopes are leveled for various reasons including house building, footpath construction as well as leveling of farm land. Excavation destabilizes slopes since it removes their lateral support, causes water stagnation and increases infiltration, leading to an increased pore water pressure and landslide risk. Southern to western sides of the mountain were observed to be at more risk than the northern part due to excavation. It is because the areas have more stepper slopes. Fortunately, the encroached area in MENP had little excavation of the farm lands because of limited human settlement.

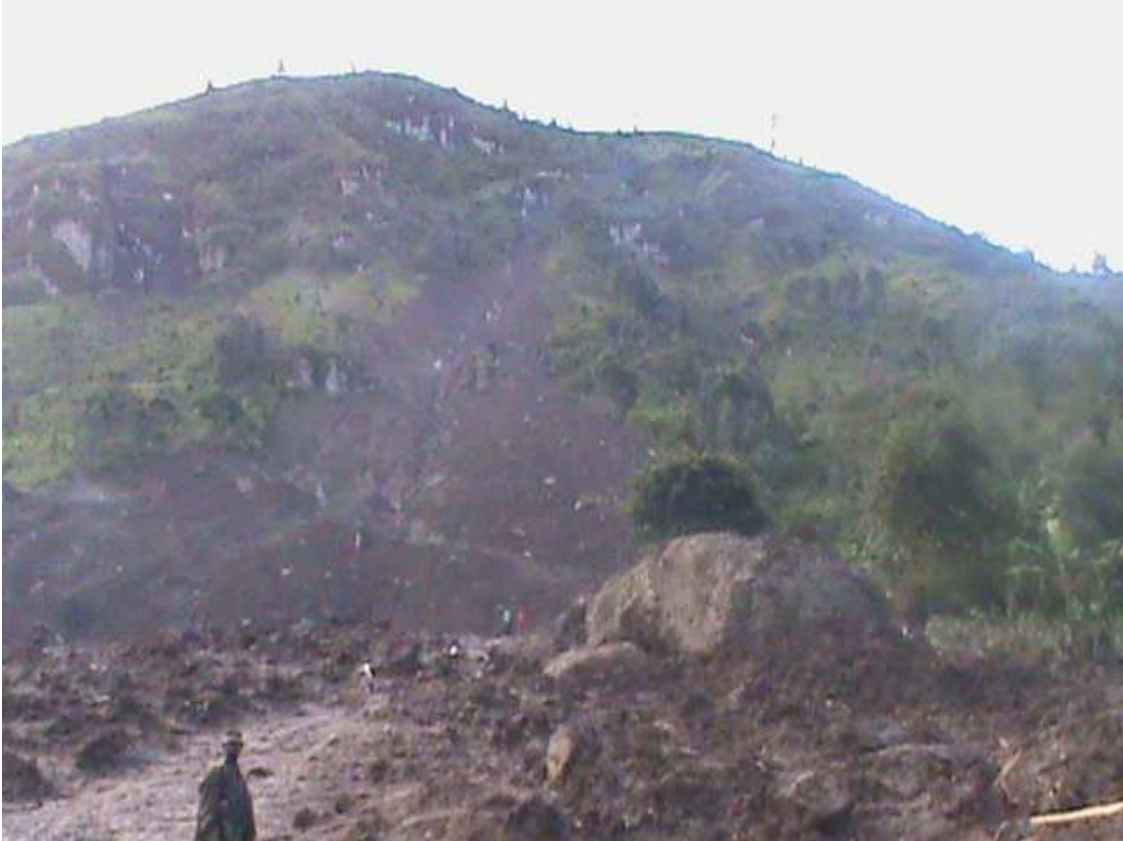
Figure 6: Several agricultural encroachments on MENP resulted into landslides such as this one at Nametsi village in Bududa district that killed 350 people in March 2010.
